QA-70  
Steele House  
Ingleside  
Private

circa 1840-55

## INVENTORY FORM FOR STATE HISTORIC SITES SURVEY

Irvin Steele House

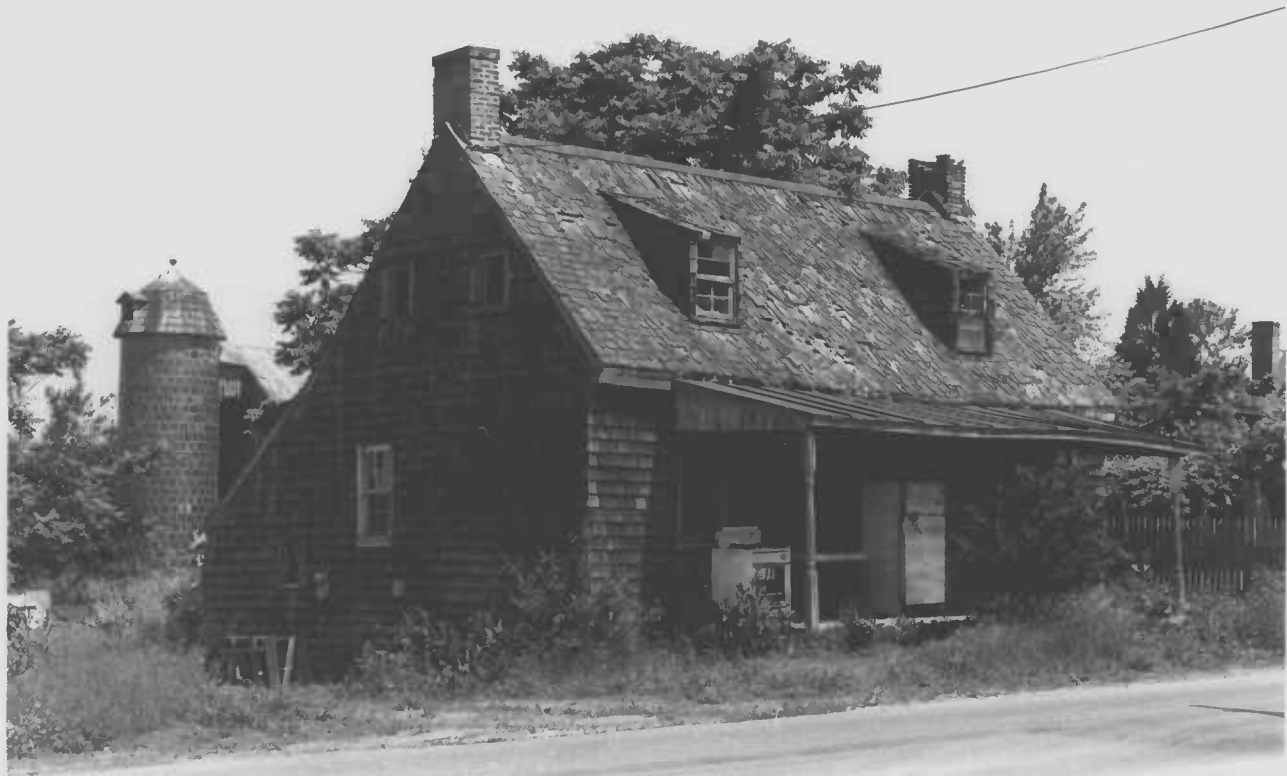
QA-70

The front facade faces southeast, directly adjacent to the road. There are two doors in the center of the facade and one 6/6 window to left and right. Two 6/6 shed roof dormers are positioned on the second floor. The house is covered with wood shingle siding and roofing, and rests on a continuous brick foundation. The eaves are boxed in but are otherwise left plain. A one story open porch protects the majority of the front facade.

Irwin Steele House  
Ingleside, Maryland  
Orlando Ridout V 1980  
Front facade from South
